APOLLO PROGRAM

# FINAL FLIGHT EVALUATION REPORT APOLLO 10 MISSION

AUGUST 1969

FLIGHT EVALUATION REPORT - APOLLO 10 MISSION

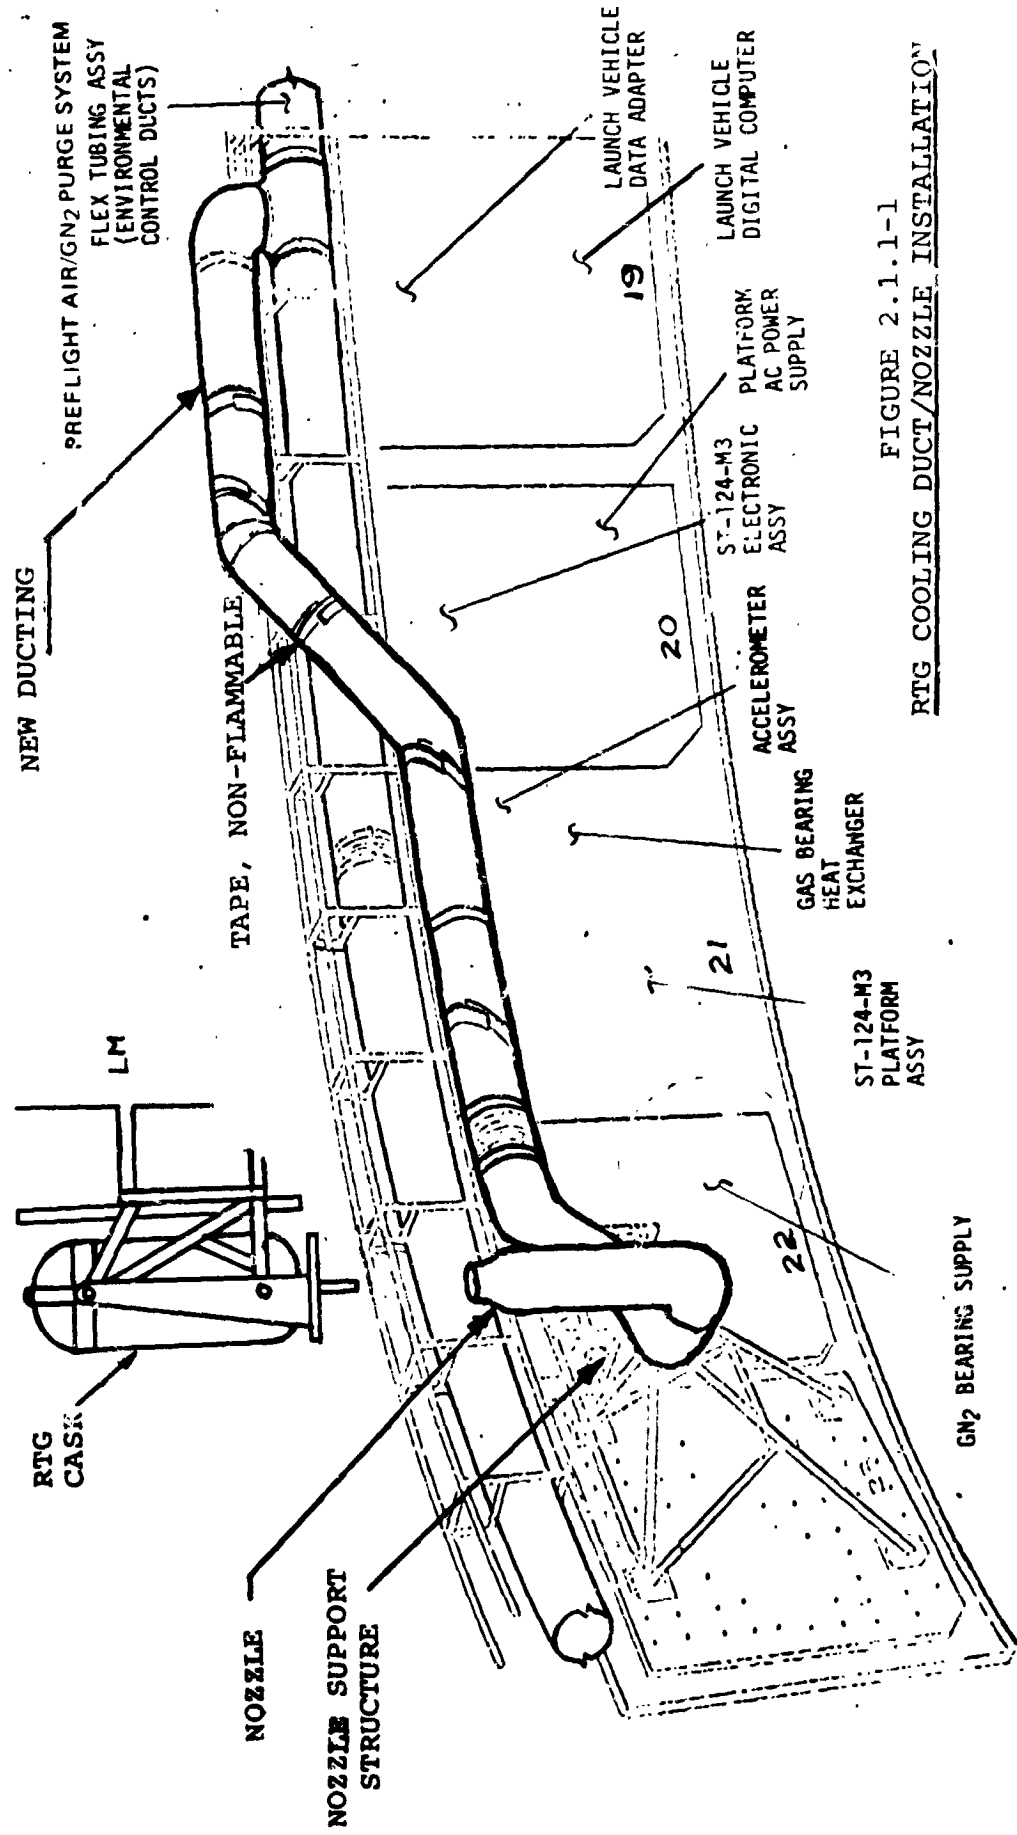
FIGURE 2.1.1-1  
RTG COOLING DUCT/NOZZLE INSTALLATION

<p>NO. 2.1.1.1</p> <p>SYSTEM: IU</p> <p>SUBSYSTEM: ECS</p>	<p>TITLE: FAILURE OF IU AIR/GN<sub>2</sub> PURGE DUCT</p> <p>MISSION: APOLO 10</p> <p>EVENT TIME: T-8:57</p> <p>PROBLEM: AFTER SWITCHOVER FROM AIR TO GN<sub>2</sub>, A REDUCTION WAS OBSERVED IN PRESSURE IN THE IU/S-IVB PURGE GASES. THE PRESSURE TRANSDUCER READING ON THE RTG COOLING NOZZLE DECREASED FROM 0.37 PSIG AT T-9:00 TO ALMOST ZERO GAGE PRESSURE AT T-8:30. THE CORRESPONDING GROUND SUPPORT EQUIPMENT (GSE) FLOWRATE INCREASED FROM AN INITIAL VALUE OF 200 LB/MIN TO AN OFF-SCALE VALUE OF MORE THAN 225 LB/MIN. THE UPSTREAM INLET PRESSURE DECREASED FROM 2.15 PSIG TO 1.66 PSIG. THE LOW PRESSURE AT THE INLET TO THE RTG NOZZLE INDICATED LOSS OF FLOW THROUGH THE NOZZLE. THE INCREASE IN FLOWRATE FROM THE GSE WITH A CORRESPONDING DECREASE IN INLET PRESSURE INDICATED THAT AN OPENING HAD OCCURRED SOMEWHERE IN THE PURGE DUCTING. THE ECS PURGE SYSTEM CONTINUED TO FUNCTION ADEQUATELY AS INDICATED BY A STABLE COMPARTMENT TEMPERATURE; THE DUCT FAILURE WAS ASSESSED AS NON-CRITICAL FOR THE APOLO 10 LAUNCH, AND THE COUNTDOWN PROCEEDED.</p> <p>MSFC TESTS INDICATE THE ECS AIR/GN<sub>2</sub> PURGE DUCT HAD A MASSIVE GAS LEAK AT THE DUCT JOINT APPROXIMATELY 4 INCHES INSIDE THE STAGE SKIN. THIS JOINT CONSISTED OF A FIBERGLASS DUCT WHICH FIT OVER A SHORT METAL DUCT STUB ATTACHED TO THE IU SKIN. THE FIBERGLASS DUCT WAS RETAINED BY A MARMAN CLAMP, WHICH WAS TORQUED TO 7+1 INCH-POUNDS.</p> <p>ACTION: AS A RESULT OF THE MSFC TESTS, A SECOND MARMAN CLAMP WILL BE ADDED, AND BOTH CLAMPS WILL BE TORQUED TO 20+2 INCH-POUNDS. THIS CONFIGURATION HAS BEEN TESTED TO 9 TIMES THE NORMAL OPERATING PRESSURE WITH NO FAILURES. THIS CHANGE (IBM ECP 1905) HAS BEEN COMPLETED ON APOLO 11, AND IT WILL BE ACCOMPLISHED ON ALL SUBSEQUENT LAUNCH VEHICLES.</p>

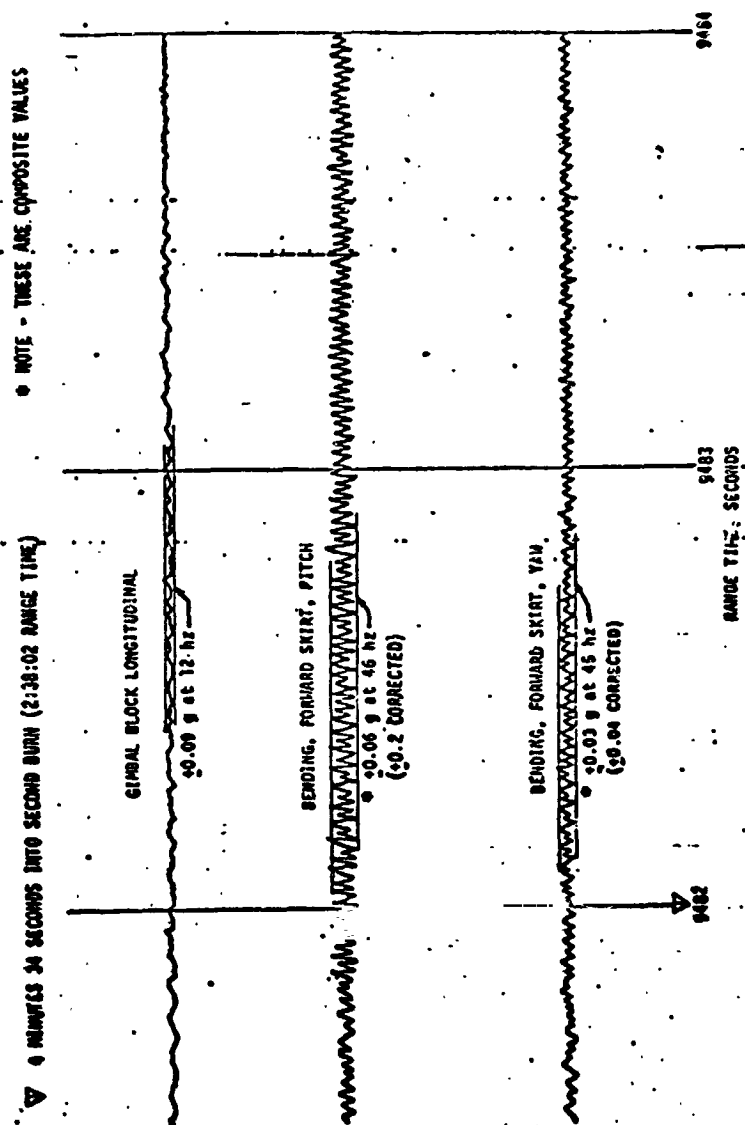
FIGURE 2.1.2-1 S-IVB SECOND BURN LONGITUDINAL AND LATERAL OSCILLATIONS

THE CREW REPORTED A LOW FREQUENCY LATERAL AND LONGITUDINAL OSCILLATION DURING BOTH S-IVB BURNS, WITH A HIGHER FREQUENCY VIBRATION SUPERIMPOSED ON IT BEGINNING 4 MINUTES AND 40 SECONDS INTO THE SECOND BURN. LONGITUDINAL 19 HZ OSCILLATIONS WERE EXPERIENCED DURING THE FIRST BURN AT A MAXIMUM AMPLITUDE OF +0.25 G ON THE LONGITUDINAL GIMBAL BLOCK ACCELEROMETER. A FREQUENCY ANALYSIS OF THE CHAMBER PRESSURE (PC) SHOWS A CHANGE IN THE THIRST OSCILLATIONS DURING THE SAME TIME OF FLIGHT. THE AS-503 S-IVB DATA SHOWED 19 HZ LONGITUDINAL OSCILLATIONS SIMILAR TO AS-505 AT ABOUT ONE-HALF THE AMPLITUDE. S-IVB-201 AND S-IVB-204 THRUST DATA SHOWED 18-19 HZ OSCILLATIONS EQUAL IN AMPLITUDE TO AS-505. LONGITUDINAL VIBRATIONS WHICH ARE RESPONSES TO UNCOUPLED THRUST OSCILLATIONS ALSO OCCURRED DURING S-IC AND S-II MAINSTAGE BURNS. THE AMPLITUDE OF THE 19 HZ THRUST OSCILLATIONS CALCULATED FROM PC IS WITHIN THE NORMAL J-2 UNCOUPLED THRUST LEVELS (NOISE LEVEL THRUST OSCILLATIONS). THE OSCILLATIONS ARE CONSISTENT WITH THE ENGINE NOISE LEVEL THRUST OSCILLATIONS AND THEY ARE OF NO CONCERN FROM STABILITY CONSIDERATIONS. SIMILAR VIBRATION LEVELS WERE ALSO PRESENT THROUGHOUT THE SECOND BURN. AN INCREASE IN THE PITCH & YAW VIBRATION LEVEL OCCURRED DURING THE SECOND BURN 4 SECONDS BEFORE THE ASTRONAUT COMMENT. THE PREDOMINANT FREQUENCY WAS 46 HZ WHICH REMAINED UNTIL ENGINE CUTOFF. THE FUEL STEP PRESSURIZATION AND VENT SEQUENCE OCCURRED 3 SECONDS BEFORE THIS VIBRATION LEVEL INCREASE. THE PROBABLE CAUSE IS THE PROXIMITY (0.1 PSI) OF THE DUAL VENT VALVE SETTINGS.

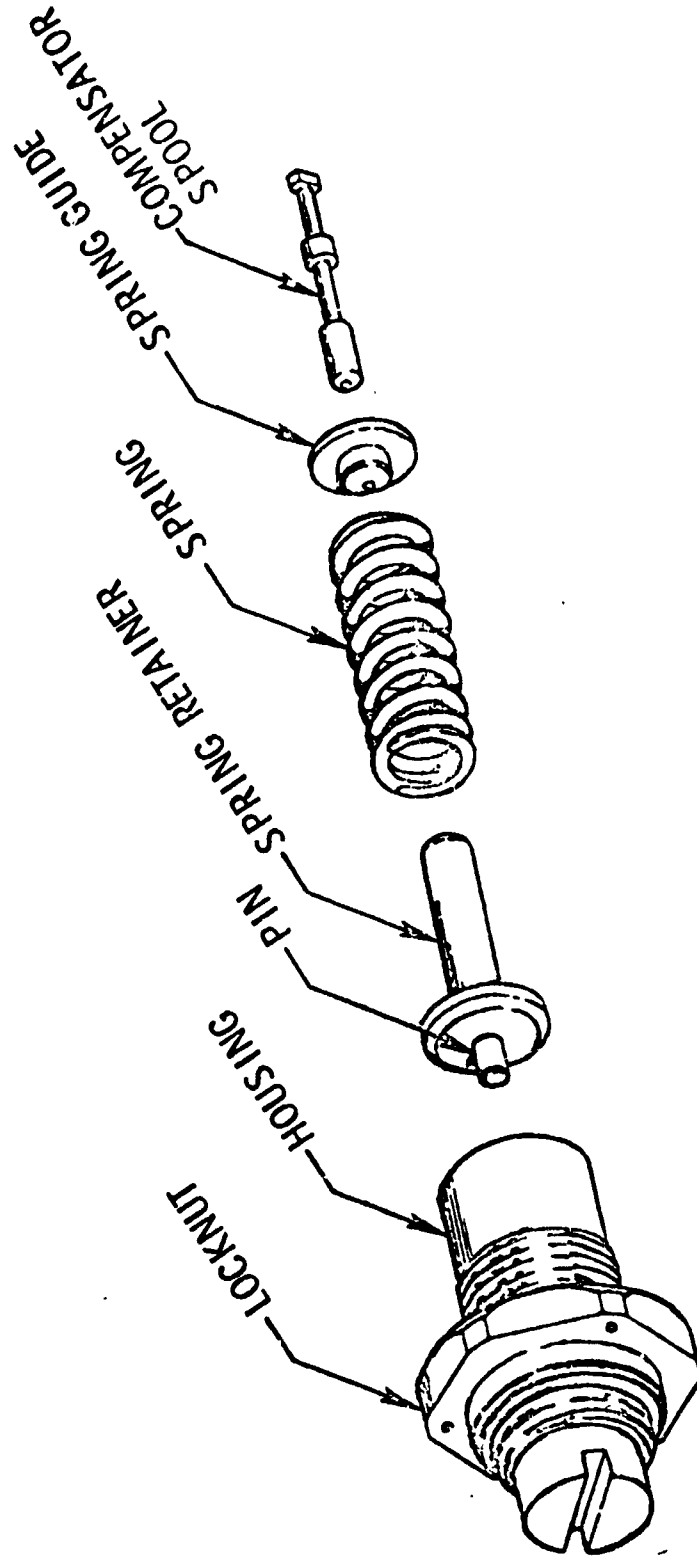
FIGURE 2.1.3-2 PRESSURE COMPENSATOR ASSEMBLY

AN AUXILIARY PUMP GROUND TEST WAS RUN IN AN ATTEMPT TO DUPLICATE THE FLIGHT DATA BY INTRODUCING KNOWN FAILURES. THE PRIME SUSPECT, STRUCTURAL FAILURE OF THE COMPENSATOR SPRING GUIDE, DID PRODUCE SIMILAR DATA. ADDITIONAL FAILURE TESTS (COMPENSATOR SPRING BREAKAGE, VALVE PLATE TORSION SPRING FRACTURE, AND STOP PIN FAILURE) DID NOT DUPLICATE FLIGHT DATA.

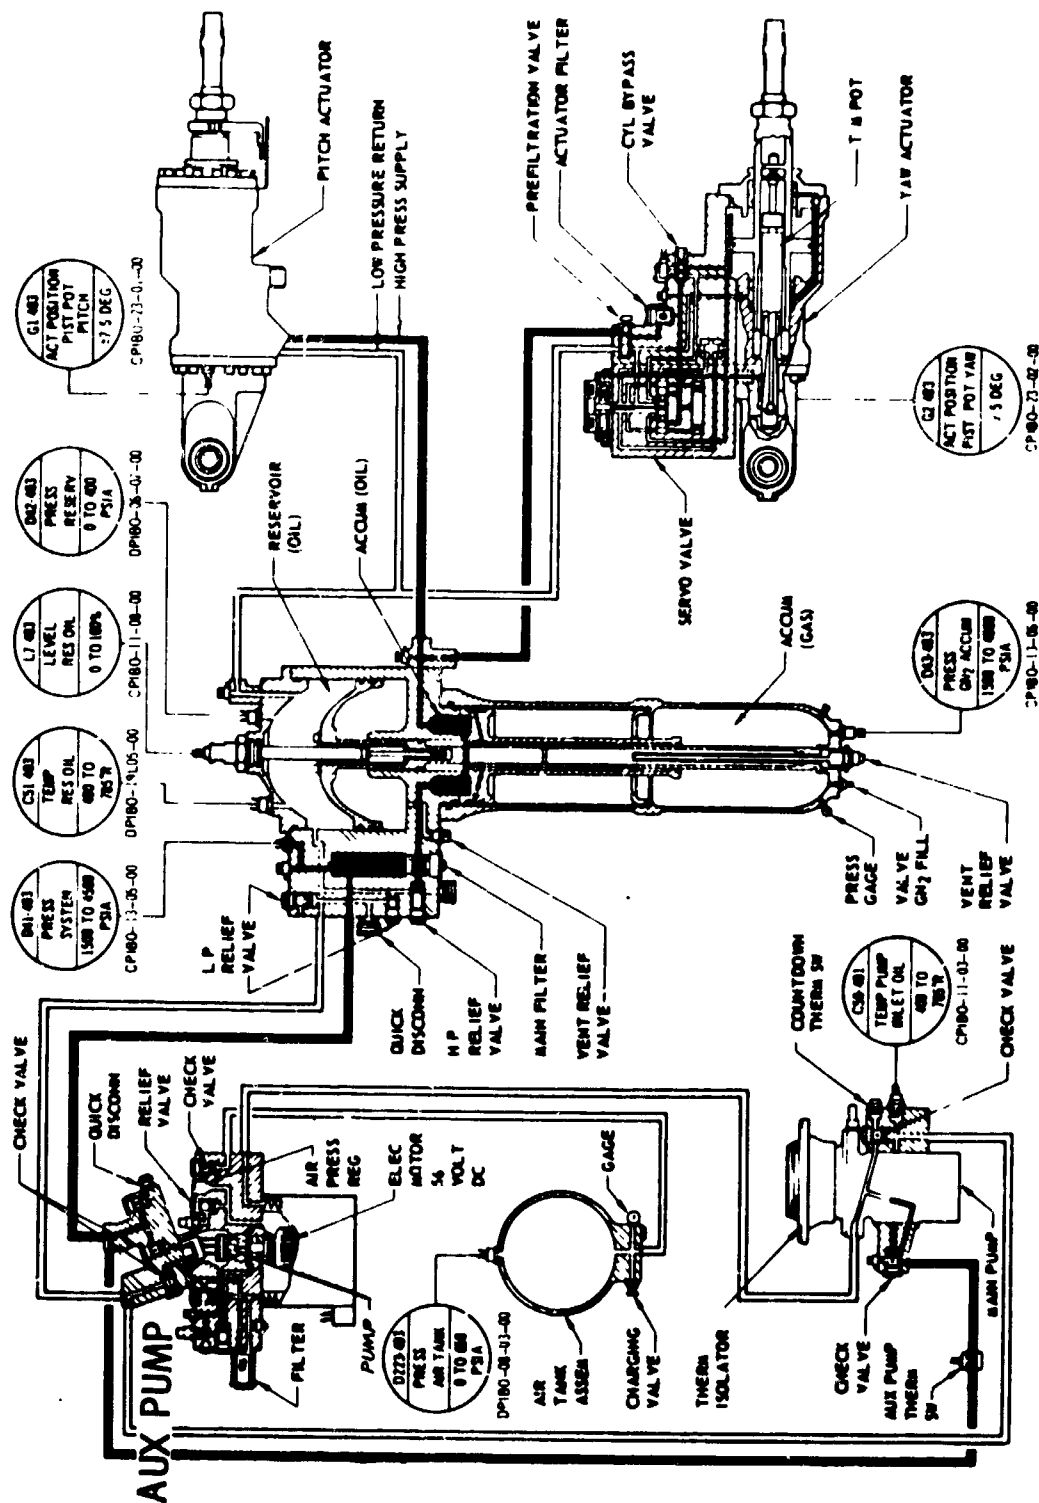
**FIGURE 2.1.3-1. S-IVB HYDRAULIC SYSTEM**

THE AUXILIARY HYDRAULIC PUMP WAS TURNED ON 6 MINUTES PRIOR TO SECOND BURN. THE ACTUATORS CENTERED THE J-2 ENGINE IN RESPONSE TO THE 3635 PSIA SYSTEM PRESSURE. AT ENGINE IGNITION, THE ACTUATORS RESPONDED NORMALLY TO THE APPLIED GUIDANCE SIGNALS. THE AUXILIARY PUMP RESPONDED BRIEFLY WITH HIGH FLOW TO MEET THIS DEMAND WHILE THE ENGINE DRIVEN PUMP WAS BROUGHT UP TO SPEED. SHORTLY AFTER ENGINE IGNITION, THE ENGINE DRIVEN PUMP OUTPUT PRESSURE EXCEEDED THE NORMAL 3635 PSIA BY 3 PERCENT. THE AUXILIARY PUMP RESPONDED TO THIS EXCESS PRESSURE BY FEATHERING TO THE NO-FLOW CONDITION WITH A CORRESPONDING DROP TO A CONTINUOUS 21 AMPERE DEMAND. AT ABOUT 2:37 GET, THE AUXILIARY PUMP CURRENT DECREASED UNEXPECTEDLY TO 19 AMPERES. THE CURRENT REMAINED AT THIS LEVEL DURING THE 4.1 SECOND INTERVAL FOLLOWING ENGINE CUTOFF INSTEAD OF RISING TO THE NORMAL 40 TO 70 AMPERES.

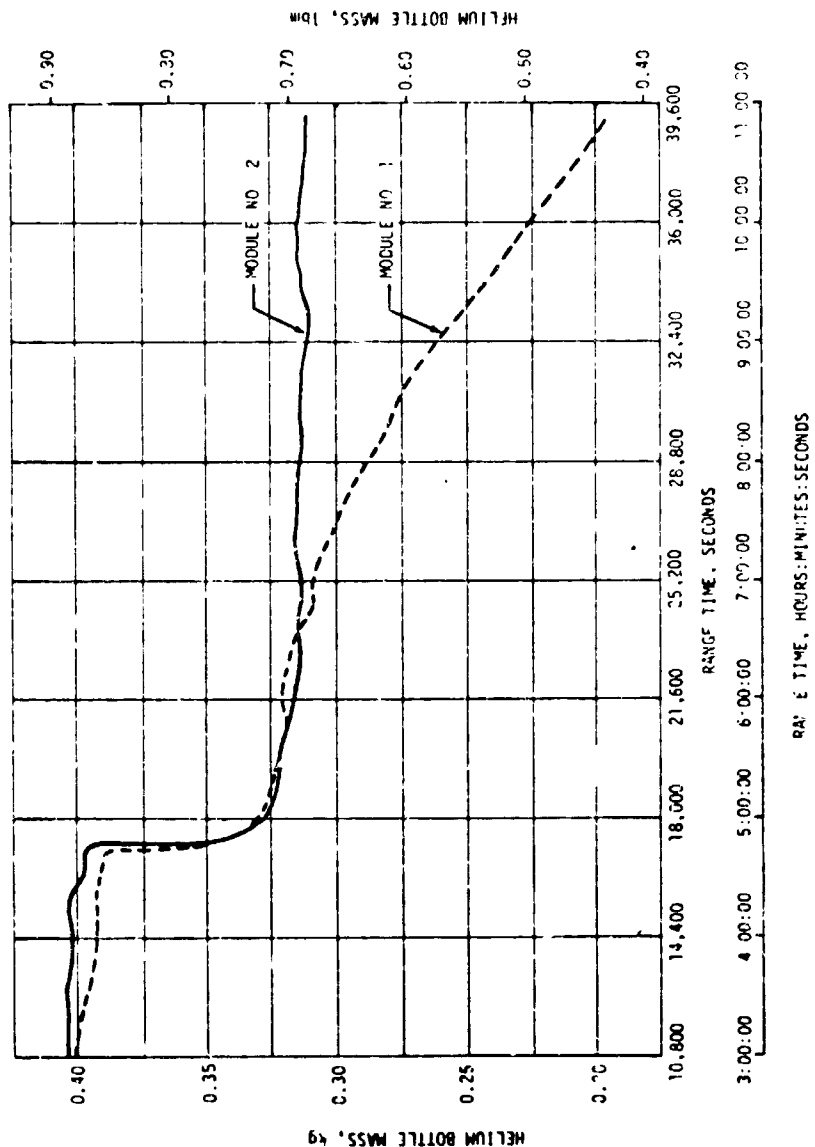
FIG. 2.1.4. S-IVB APS HELIUM BOTTLE MASS

NO. 2.1.1.4	TITLE: S-IVB APS MODULE HELIUM LEAK  SYSTEM: S-IVB SUBSYSTEM: APS	MISSION: APOLLO 10  EVENT TIME: 6:30
<p><b>PROBLEM:</b> THE OPERATIONS OF THE APS PRESSURIZATION SYSTEM WAS SATISFACTORY WITH THE EXCEPTION OF A HELIUM LEAK IN MODULE NO. 1. THE LEAK STARTED APPROXIMATELY 6.5 HOURS AFTER LIFTOFF AND EXTENDED THROUGH LOSS OF DATA (10:54:00). THE LEAK RATE AT LOSS OF DATA WAS APPROXIMATELY 3278 SCCM (200 SCIM).</p>		
<p><b>ACTION:</b> AS A RESULT OF A SIMILAR LEAK WHICH OCCURRED ON AS-504 (APOLLO 9), FIVE "O" RINGS IN THE HIGH-PRESSURE HELIUM PLUMBING WERE CHANGED ON APOLLO 10 AND SUBSEQUENT. THE LEAKAGE RATES EXPERIENCED ON APOLLO 9 AND APOLLO 10 WOULD NOT IMPAIR THE ACCOMPLISHMENT OF THE S-IVB PORTION OF THE APOLLO 11 MISSION.</p>		
ORGANIZATION: REFERENCES:	5-2490 APOLLO 11 FRR FLIGHT EVALUATION REPORT - AS-505 APOLLO 10 MISSION MPR-SAT-FE-69-7	RESOLUTION: CLOSED  DATE:  REV:

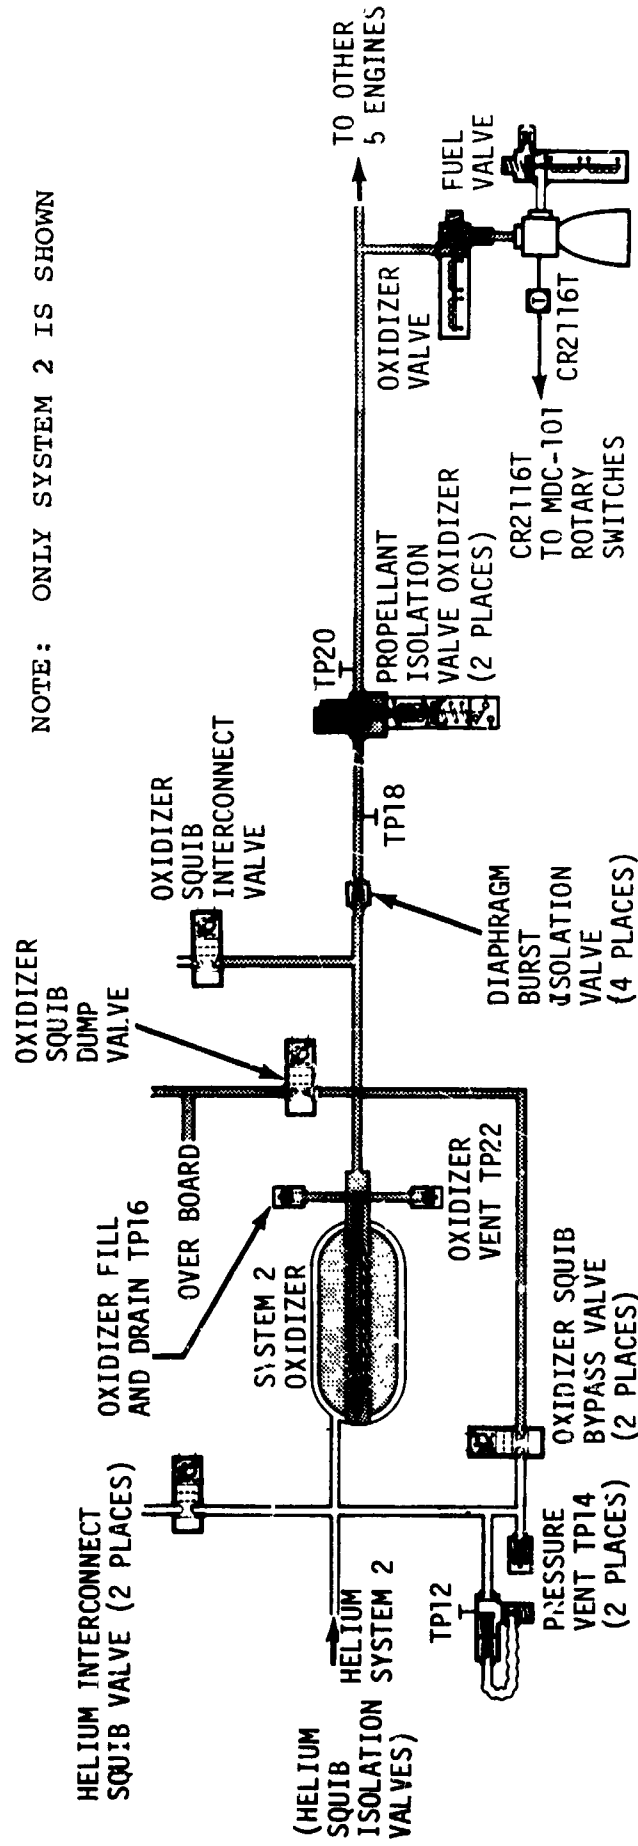
Figure 2.2.2-1. CM RCS OXIDIZER SUPPLY

<b>NO. 2.2.2</b>	<b>TITLE:</b> CM RCS OXIDIZER LINE BURST DIAPHRAGM FAILURE  <b>MISSION:</b> APOLLO 10  <b>EVENT TIME:</b> T-9:26	<p><b>PROBLEM:</b> DURING THE FINAL SWITCH LIST VERIFICATION, WHEN THE PROPELLANT ISOLATION VALVES OF THE COMMAND MODULE RCS SYSTEM WERE OPENED, THE PRESSURE IN THE CM RCS HELIUM SYSTEM 2 DROPPED FROM 44 PSIA TO 37 PSIA. THIS INDICATED THAT THE OXIDIZER PROPELLANT BURST DIAPHRAGM WAS RUPTURED, ALLOWING OXIDIZER TO FLOW FROM THE TANK INTO THE MANIFOLD WHEN THE ISOLATION VALVE WAS OPENED. THE OXIDIZER ISOLATION VALVE BACKED UP BY THE ENGINE VALVES PREVENTED LOSS OF OXIDIZER, AND THE SYSTEM WAS VISUALLY VERIFIED TO BE LEAK-TIGHT; THEREFORE, IT WAS DECIDED THAT THE SYSTEM WAS ACCEPTABLE FOR FLIGHT. THE ISOLATION VALVES WERE CLOSED AFTER ORBITAL INSERTION. THE ENGINE VALVES WERE THEN OPENED BY MEANS OF THE REACTION CONTROL HEATER CIRCUITS, AND THE OXIDIZER WAS VENTED FROM THE MANIFOLD FOR 25 MINUTES. FOUR PERCENT OF THE OXIDIZER IN SYSTEM 2 WAS LOST, HOWEVER, THE MAXIMUM PREVIOUS PROPELLANT USAGE DURING A MISSION WAS 35% OF ONE SYSTEM. AFTER THE MISSION, THE OXIDIZER AND FUEL BURST DISCS WERE SIMILAR IN PHYSICAL APPEARANCE, INDICATING THAT THE OXIDIZER BURST DISC HAD FAILED BECAUSE OF PRESSURE.</p> <p><b>ACTION:</b> CAUTION NOTES HAVE BEEN ADDED TO THE PRELAUNCH CHECKOUT PROCEDURES IN THE PLACES WHERE THE ALLOWABLE LIMITS ON THE BURST DISC (241 +16 PSID IN THE FLOW DIRECTION AND 10 PSID IN THE REVERSE DIRECTION) COULD BE EXCEEDED. TO ALLOW EARLY DETECTION OF ANY SIMILAR PROBLEM IN THE FUTURE, A LEAK CHECK OF THE BURST DISC HAS BEEN ADDED AFTER REACTION CONTROL SYSTEM PROPELLANT SERVICING.</p>

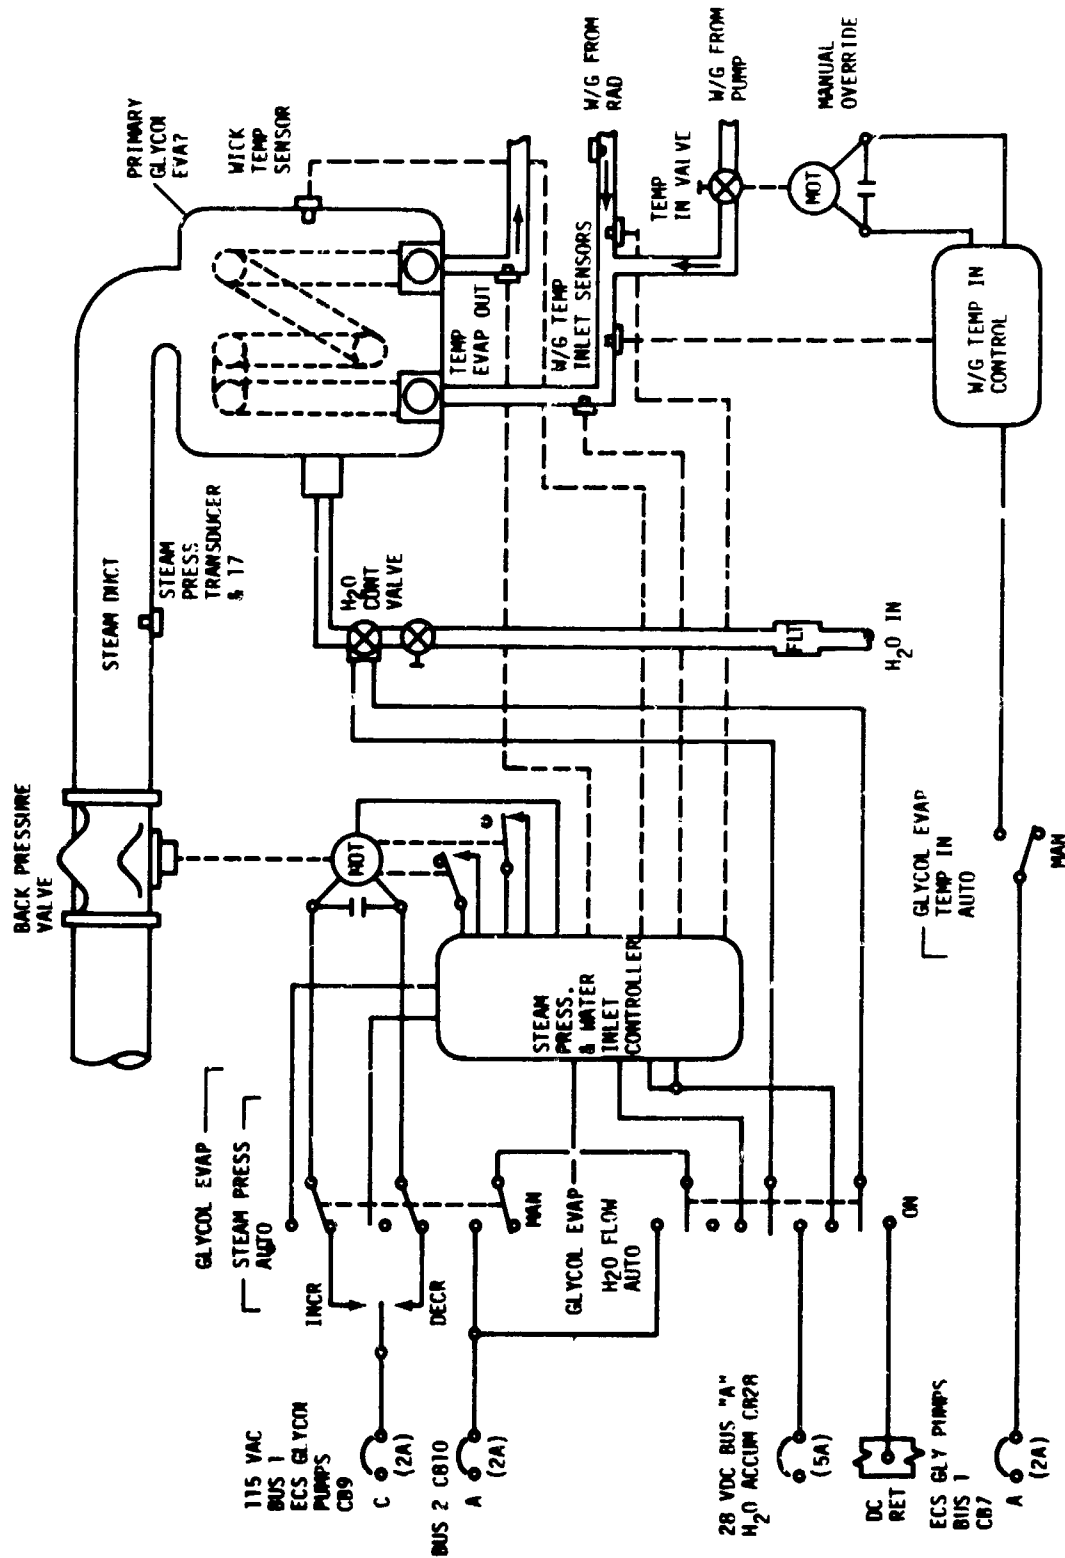
FIG. 2.2.3-1 PRIMARY WATER GLYCOL EVAPORATOR CONTROL

NO. 2.2.3	TITLE: PRIMARY ECS EVAPORATOR DRIED OUT	MISSION: APOLLO 10	EVENT TIME: 0:08 AND 78:38 GET
SYSTEM: CM			
SUBSYSTEM: ECS			
PROBLEM:	<p>THE PRIMARY EVAPORATOR IN THE ENVIRONMENTAL CONTROL SYSTEM BEGAN OPERATION SOON AFTER LIFT-OFF BUT DRIED OUT AFTER ONLY A FEW MINUTES. THE SECONDARY COOLING SYSTEM WAS ACTIVATED AND FUNCTIONED NOMINALLY. THE PRIMARY EVAPORATOR WAS DEACTIVATED AND WAS NOT RESERVICED WITH WATER UNTIL JUST PRIOR TO LUNAR ORBIT INSERTION. IT DRIED OUT AGAIN DURING THE SECOND LUNAR ORBIT. JUST PRIOR TO ENTRY, THE EVAPORATOR WAS SERVICED AGAIN. DURING ENTRY, IT FUNCTIONED NORMALLY, BUT INFORMATION IS NOT AVAILABLE TO INDICATE WHETHER OR NOT ADDITIONAL WATER WAS AUTOMATICALLY PROVIDED TO THE EVAPORATOR.</p>		
ACTION:	<p>A CHECK OF THE SWITCH ASSEMBLY REVEALED THAT THE ACTUATOR MOVED AS LITTLE AS 0.0008 INCH BEYOND THE POINT AT WHICH THE SWITCH SHOULD HAVE OPENED. WITH CHANGES IN ENVIRONMENT, THE ACTUATOR TRAVEL WAS AT TIMES NOT SUFFICIENT TO OPEN THE SWITCH. ACTUATOR RIGGING PROCEDURES WILL BE MODIFIED TO ASSURE PROPER OVERTRAVEL.</p>

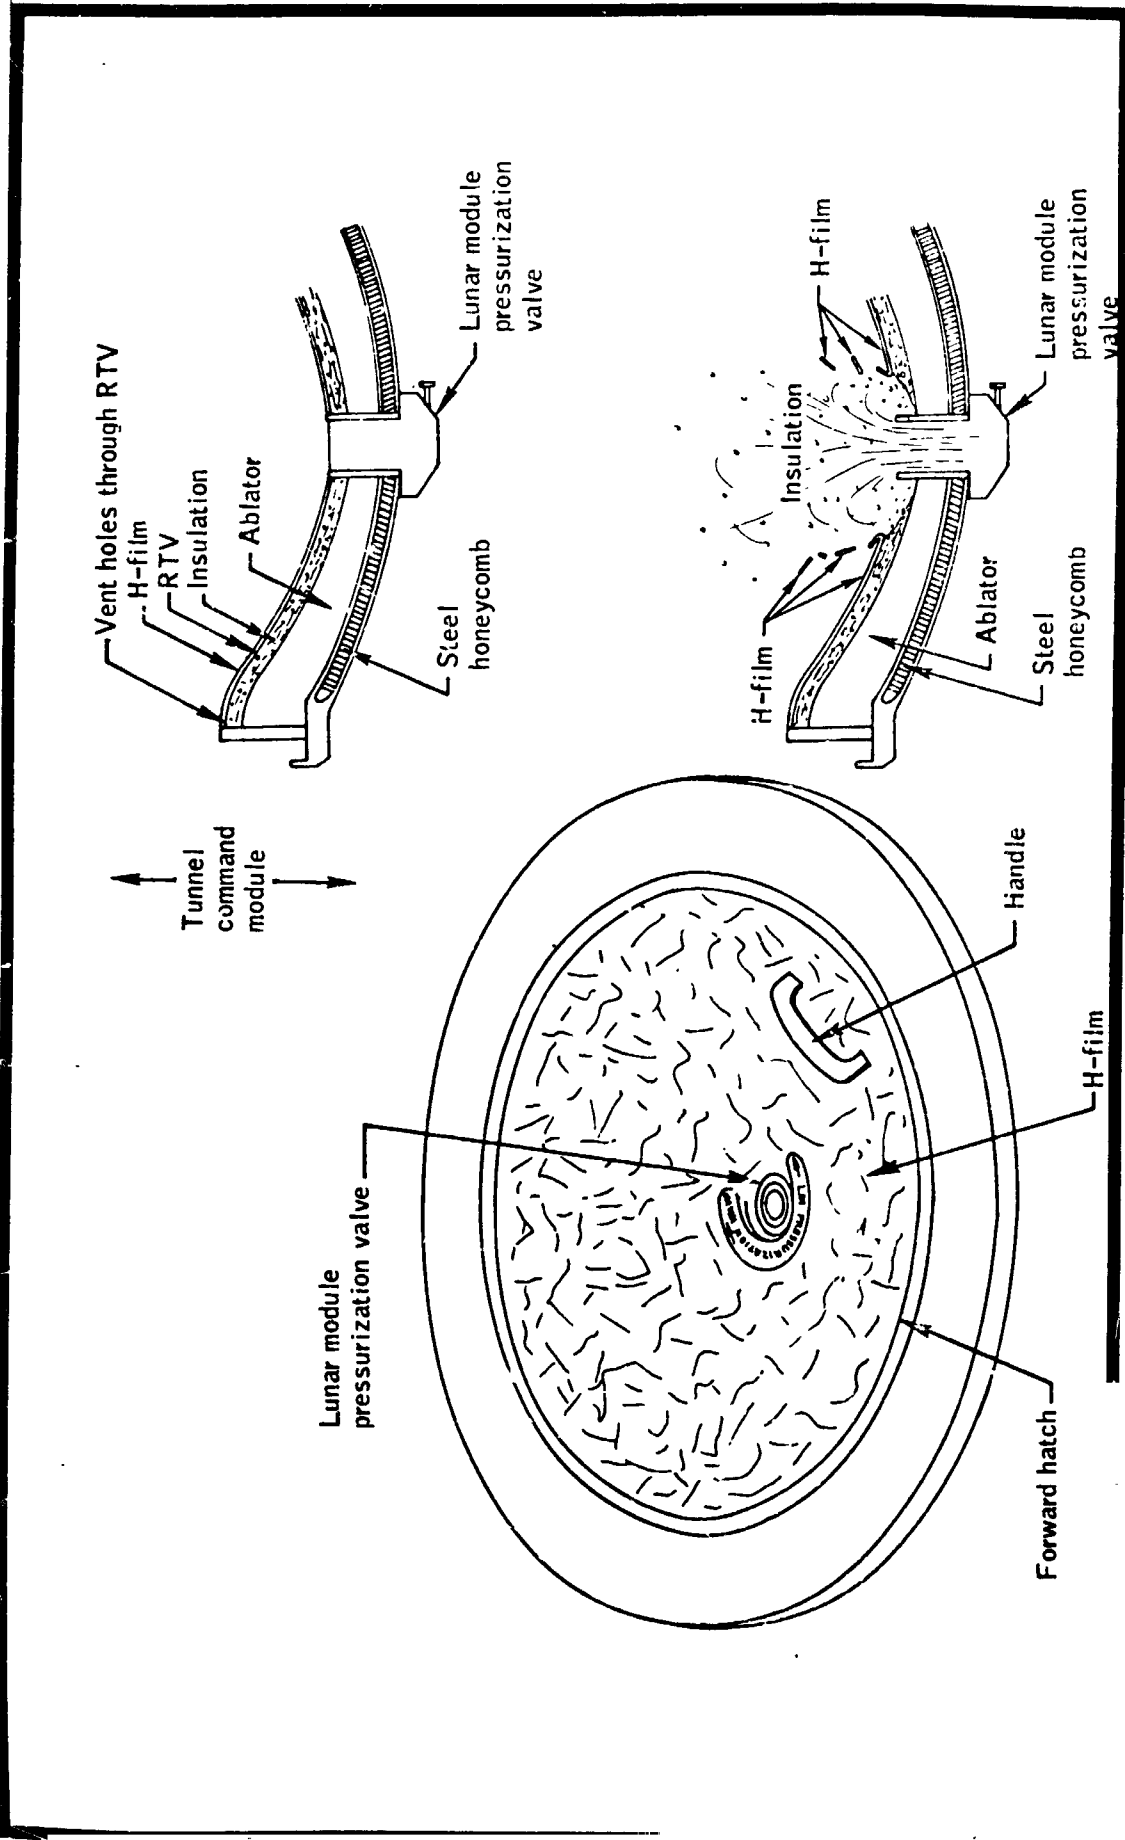
FIG. 2.2.6-1 FORWARD HATCH THERMAL COATING.

NO. 2.2.6	TITLE: THERMAL COATING ON FORWARD HATCH FLAKED OFF	MISSION: APOLLO 10 EVENT TIME: 3:54
SYSTEM: CM	SUBSYSTEM: STRUCTURE	
PROBLEM:	<p>WHEN THE LUNAR MODULE CABIN WAS FIRST PRESSURIZED THE THERMAL COATING ON THE COMMAND MODULE HATCH CAME OFF IN PIECES. THE INSULATION BLANKET VENT HOLES WERE PLUGGED, PRODUCING THE DAMAGE. ONE POSSIBILITY IS THAT THE PREFLIGHT BAKING OF THE HATCH AT 900°F FOR 15 HOURS WEAKENED THE INSULATION TO THE EXTENT THAT INTERNAL PIECES OF INSULATION BROKE LOOSE AND PLUGGED THE HOLES DURING TUNNEL DEPRESSURIZATION. ANOTHER POSSIBILITY IS THAT THE VENT HOLES WERE INADVERTENTLY SEALED WHEN THE INSULATION BLANKET WAS POTTED WITH RTV OR WHEN THE H-FILM TAPE WAS INSTALLED ON THE HATCH SURFACE.</p>	
ACTION:	<p>ON THE APOLLO 11 COMMAND MODULE, THE INSULATION HAS BEEN DELETED BECAUSE OF THE EFFECTS NOTED AND BECAUSE A REEVALUATION OF THERMAL CONDITIONS HAS SHOWN THAT THE INSULATION IS NOT NECESSARY. HOWEVER, TO MINIMIZE CONDENSATION, A SINGLE LAYER OF H-FILM TAPE HAS BEEN APPLIED OVER THE EXTERIOR SURFACE OF THE HATCH ABLATOR. SOME WATER AND ICE CAN BE EXPECTED ON APOLLO 11 BUT TO A LESSER DEGREE THAN OBSERVED ON APOLLO 10.</p>

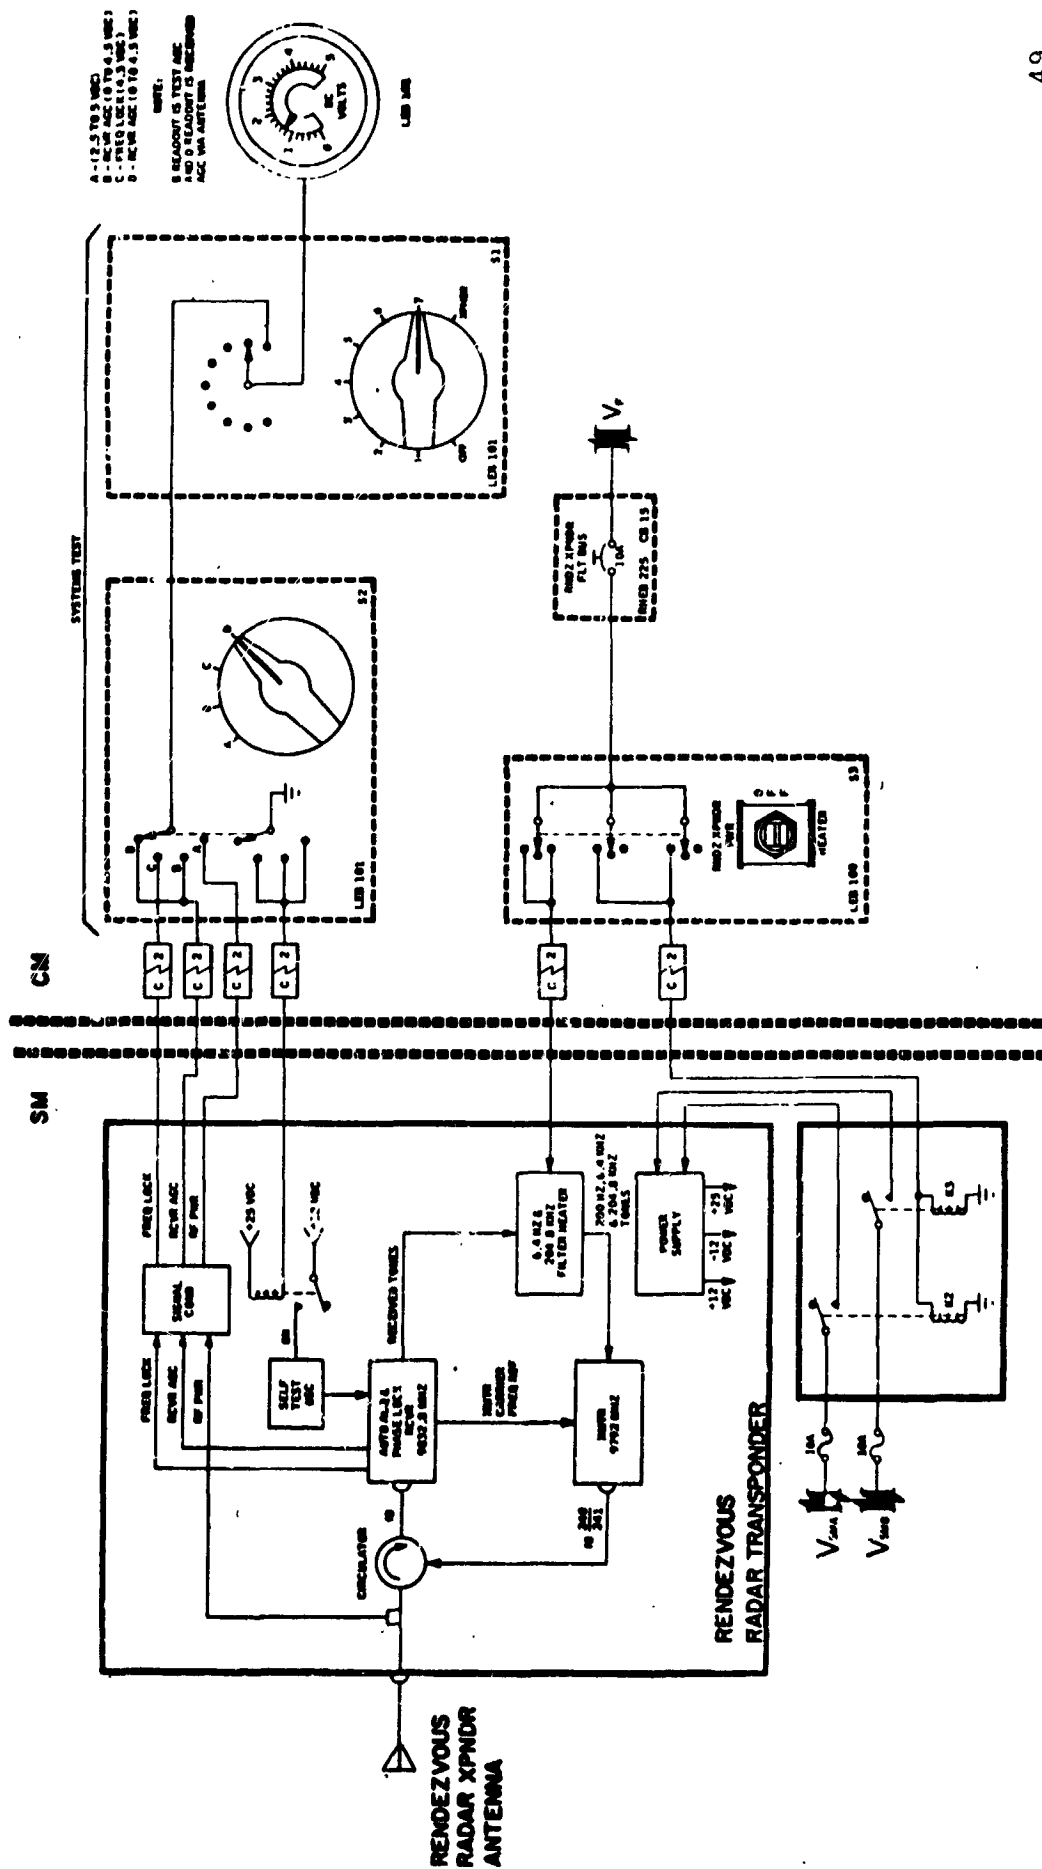
FIGURE 2.2.9-1 RENDEZVOUS RADAR TRANSPONDER CONTROL CIRCUITRY

NO. 2.2.9	TITLE: CM RENDEZVOUS RADAR TRANSPONDER FAILED TO OPERATE  MISSION: APOLLO 10  EVENT TIME: 98:51	
SYSTEM: CSM	SUBSYSTEM: RENDEZVOUS RADAR	
<b>PROBLEM:</b> FOLLOWING UNDOCKING, THE RENDEZVOUS RADAR TRANSPONDER IN THE COMMAND MODULE WOULD NOT OPERATE. AN EARLIER SELF-TEST HAD BEEN CONDUCTED SUCCESSFULLY. THE COMMAND MODULE PILOT CHECKED THE CIRCUIT BREAKER AND INITIATED THE SELF-TEST; ALL READINGS WERE ZERO. THE THREE-POSITION PWR-OFF-HEATER SWITCH WAS CYCLED TO OFF AND BACK TO PWR. THE TRANSPONDER THEN WORKED PROPERLY FOR THE REMAINDER OF ITS USE.		
<b>ACTION:</b> DURING POSTFLIGHT TESTS OF THE SWITCH AND WIRING, NO DEFECTS WERE FOUND, AND THE ANOMALY CANNOT BE ATTRIBUTED TO ANY CM HARDWARE.		
<b>ORGANIZATION:</b> 5-2490 <b>REFERENCES:</b> MSC 5-DAY REPORT, P. 14 MSC FAILURE AND ANOMALY LISTING, P. 2	RESOLUTION: CLOSED  DATE:	REV:
		48

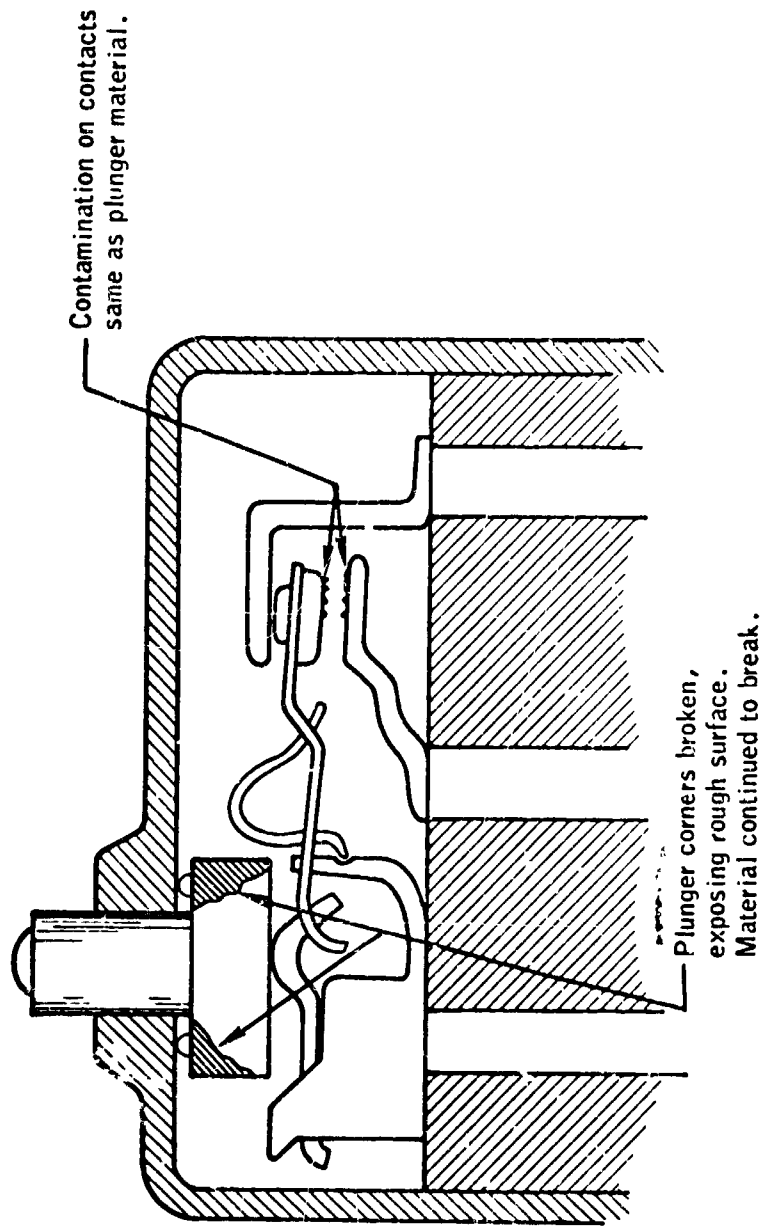
FIG. 2.2.10-1 MAGAZINE INTERLOCK SWITCH.

NO. 2.2.10	TITLE: CM SEQUENCE CAMERA	SYSTEM: CM	MISSION: APOLLO 10
SUBSYSTEM:	CAMERA	EVENT TIME: 173	
<b>PROBLEM:</b> AT APPROXIMATELY 173 HOURS, DURING TRANSEARTH COAST, THE COMMAND MODULE 16-MM CAMERA CEASED TO OPERATE IN THE PULSE MODE BECAUSE THE MAGAZINE INTERLOCK MICROSWITCH FAILED. THE SWITCH WAS NOT A HIGH RELIABILITY ITEM AND FAILED BECAUSE OF INTERNAL CONTAMINATION AND A FAULTY PLUNGER.			
<b>ACTION:</b> HIGH RELIABILITY MICROSWITCHES HAVE BEEN INSTALLED IN THE CAMERAS FOR APOLLO 11 AND SUBSEQUENT.			
ORGANIZATION:	5-2490	REFERENCES: MSC FAILURE AND ANOMALY LISTING JUNE 1969	RESOLUTION: CLOSED
			DATE:
			REV:
			50

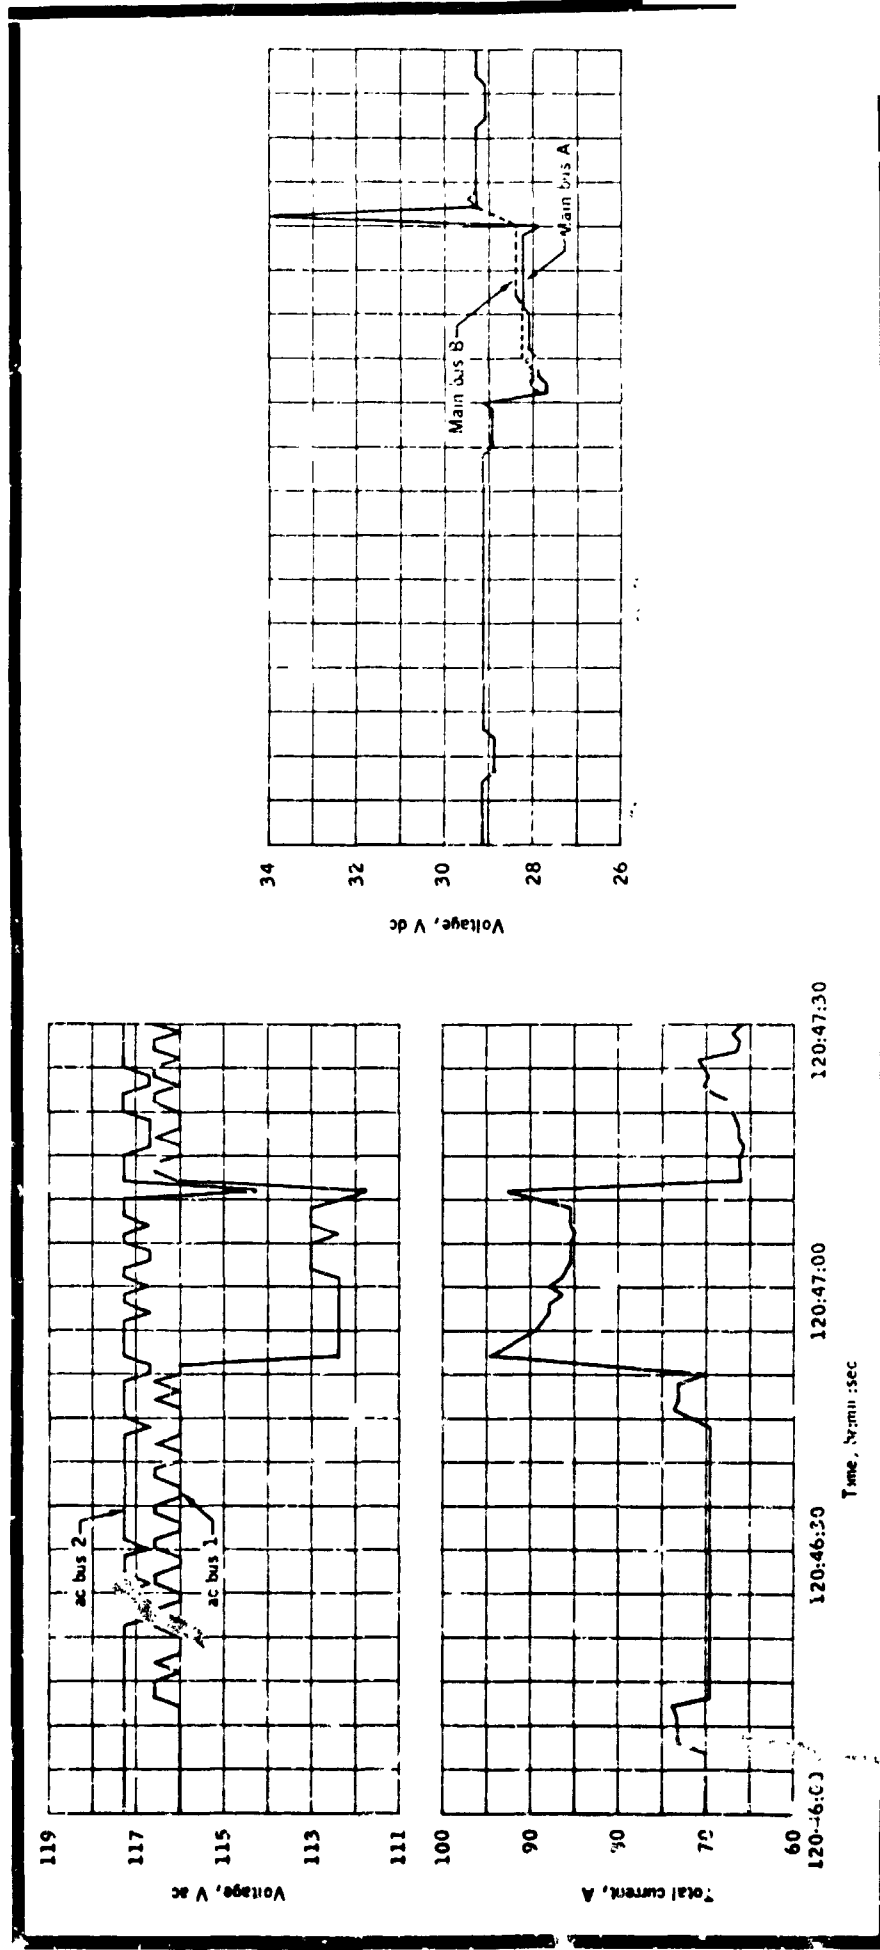
FIG. 2.2.11-1 POWER VARIATIONS AT PUMP FAILURE.

<p>NO. 2.2.11</p> <p>SYSTEM: SM</p> <p>SUBSYSTEM: ELECTRIC POWER</p>	<p>TITLE: FUEL CELL 1 AC CIRCUIT BREAKER OPEN</p> <p>MISSION: APOLLO 7</p> <p>EVENT TIME: 120:47</p> <p>PROBLEM: AT 120 HOURS 47 MINUTES, A SHORT CIRCUIT IN THE AC PUMP PACKAGE OF FUEL CELL 1 CAUSED THE ASSOCIATED CIRCUIT BREAKER TO TRIP. FUEL CELL 1 PERFORMANCE WAS NORMAL UP TO THIS TIME. FIG. 2.2.11-1 SHOWS THE OBSERVED CURRENT AND VOLTAGE VARIATIONS. THE BREAKER COULD NOT BE RESET; THEREFORE, FUEL CELL 1 WAS REMOVED FROM THE BUS BECAUSE BOTH THE HYDROGEN AND THE COOLANT PUMPS WERE INOPERATIVE. THE FUEL CELL WAS THEREAFTER PLACED ON THE BUS ONLY WHEN THE SKIN TEMPERATURE DECREASED TO 370°F; THIS PROCEDURE LEFT THE FUEL CELL OPERATIVE.</p> <p>ACTION: CIRCUIT ANALYSIS AND INVERTER TESTING INDICATED THAT THE FAILURE WAS A PHASE-TO-PHASE SHORT EITHER IN THE HYDROGEN PUMP OR IN THE GLYCOL PUMP. GLYCOL PUMPS, WHICH HAVE CANNED STATORS, HAVE NEVER FAILED ELECTRICALLY. EXCEPT FOR A MAJOR REDESIGN OF THE HYDROGEN PUMP, NO PROCEDURAL OR DESIGN CHANGES HAVE BEEN IDENTIFIED WHICH WOULD FURTHER IMPROVE THE RELIABILITY OF THE HYDROGEN PUMP.</p>

FAILURES OF THIS NATURE HAVE BEEN OBSERVED ON HYDROGEN PUMPS DURING ENDURANCE TESTING UNDER NORMAL OPERATING TEMPERATURES. OF FIFTEEN DEVELOPMENT POWER PLANTS THAT EXHIBITED AN INSULATION RESISTANCE EQUAL TO OR LESS THAN THE APOLLO 10 UNIT, SIX HAD SHORTS IN THE HYDROGEN PUMP STATOR WINDINGS. FOUR OF THESE SIX WERE PHASE-TO-PHASE, AND THE OTHER TWO WERE PHASE-TO-GROUND. THIS KIND OF FAILURE IS CAUSED BY THE HOT, MOIST HYDROGEN FLOWING ACROSS THE WINDINGS; THE INSULATION IS DEGRADED AND PHASE-TO-PHASE-TO-PHASE SHORTS RESULT. IN THESE TESTS, NO STATOR FAILED IN LESS THAN 1000 HOURS, AND THE MAXIMUM TIME TO FAILURE WAS 3960 HOURS. THE UNIT FLOWN ON APOLLO 10 HAD OPERATED APPROXIMATELY 300 HOURS.

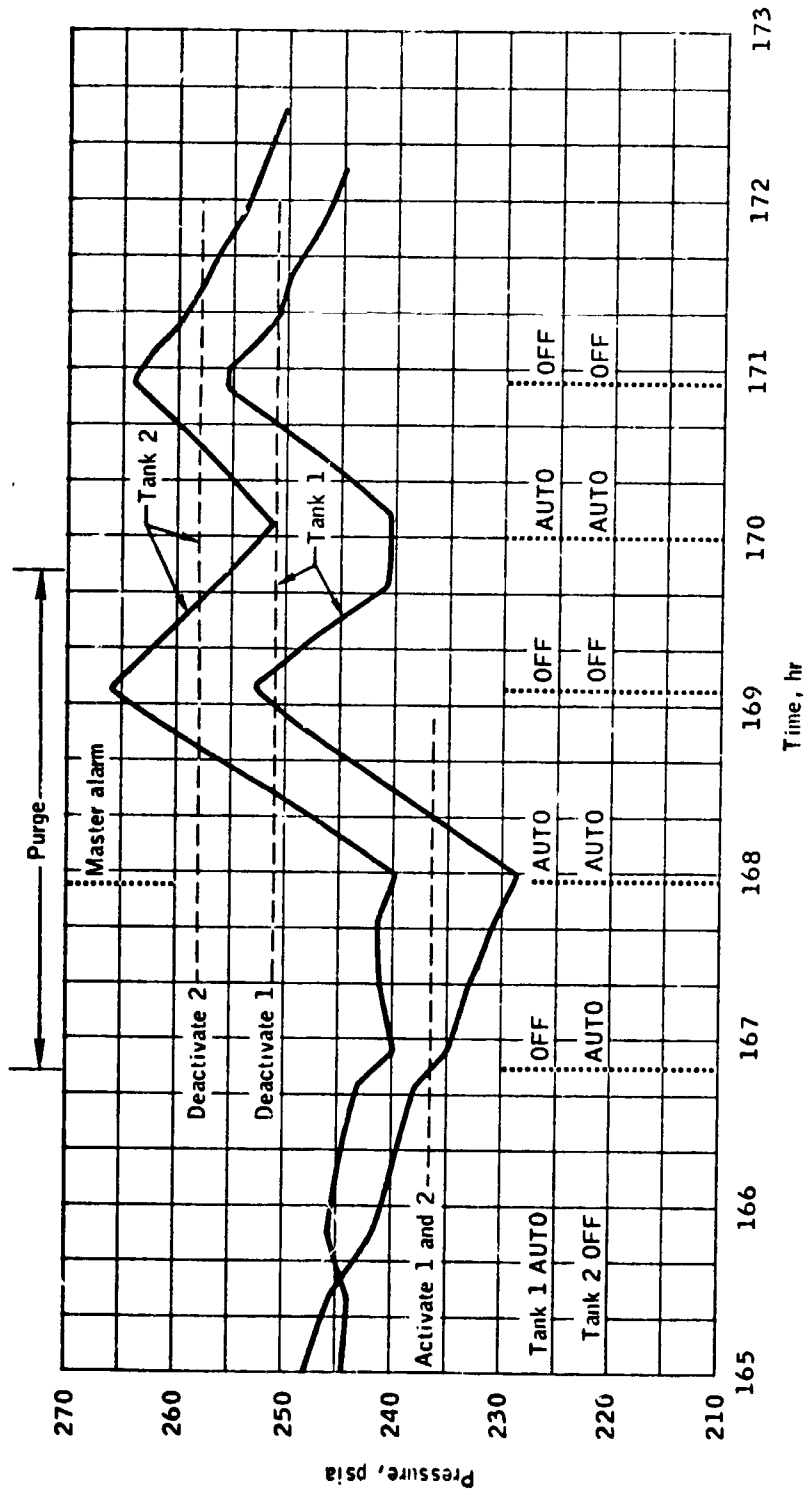
FIG. 2.2.13-1 HYDROGEN PRESSURES DURING APPARENT FAILURE OF AUTOMATIC PRESSURE CONTROL

<b>NO. 2.2.13</b>	<b>TITLE:</b> CRYOGENIC HYDROGEN AUTOMATIC HEATER CONTROL FAILURE TO TURN OFF
<b>SYSTEM:</b> SM	<b>MISSION:</b> APOLLO 10
<b>SUBSYSTEM:</b> ELECTRIC POWER	<b>EVENT TIME:</b> 170:56
<b>PROBLEM:</b> <p>DURING THE 3-HOUR PURGE OF FUEL CELL 1, THE AUTOMATIC PRESSURE CONTROL SYSTEM WAS BELIEVED TO HAVE FAILED TWICE TO TURN THE HYDROGEN TANK HEATERS OFF (FIG. 2.2.13-1). AFTER 170-1/2 HOURS, THE HEATERS WERE SWITCHED ON AND OFF MANUALLY.</p> <p>FOR AUTOMATIC OPERATION, THE PRESSURE SWITCHES IN BOTH TANKS MUST CLOSE IN ORDER TO ACTUATE THE HEATERS, BUT ONLY ONE PRESSURE SWITCH MUST OPEN TO DEACTIVATE THEM AS SHOWN IN FIG 2.2.13-2 THE HEATERS IN TANK 1 WERE IN AUTO AND THOSE IN TANK 2 WERE IN OFF BEFORE THE PURGE WAS STARTED. ALSO, THE PRESSURE SWITCH FOR TANK 1 WAS OPEN AND THAT OF TANK 2 WAS CLOSED. SHORTLY AFTER THE PURGE WAS STARTED, THE HEATERS IN TANK 1 WERE SWITCHED TO OFF AND IN TANK 2 TO AUTO; THIS CHANGE WAS MADE TO BALANCE THE QUANTITY IN THE TWO TANKS. AFTER 5 MINUTES OF PURGING, THE PRESSURE SWITCH IN TANK 1 CLOSED AT 236 PSIA, ACTIVATING THE HEATERS IN TANK 2 AND AFFECTING PRESSURES IN THE MANNER EXPECTED. SINCE THE PRESSURE IN TANK 1 CONTINUED TO DROP AND A MASTER ALARM WAS RECEIVED, THE HEATERS IN TANK 1 WERE TURNED TO AUTO. AS SHOWN IN FIG 2.2.13-1, THE PRESSURES WERE AT A MAXIMUM OF 8 PSIA ABOVE THE SWITCHING LEVEL WHEN THE HEATERS WERE MANUALLY TURNED OFF.</p> <p><b>ACTION:</b> THE TRANSDUCERS ON APOLLO 10 WERE SUBJECTED TO TEMPERATURES BETWEEN MINUS 100° AND MINUS 140°F DURING THE EXTENDED PURGE; THE TRANSDUCER OUTPUT DRIFTED UPWARD AND CREATED AN APPARENT LOSS OF AUTOMATIC PRESSURE CONTROL. LONG-DURATION PURGES WILL NOT BE PERFORMED ON FUTURE FLIGHTS. THE APOLLO OPERATIONS HANDBOOK HAS BEEN CHANGED APPROPRIATELY.</p>	<b>ORGANIZATION:</b> 5-2490 <b>REFERENCES:</b> APOLLO 10 MISSION FAILURE AND ANOMALY LISTING
